# **Sixth Street Reconstruction North Boulevard**

## **Arborist Report**

prepared by:  
Envision-Tatham Inc.  
115 Sandford Fleming Drive, Suite 200  
Collingwood, ON L9Y 5A6

prepared for:  
Town of Collingwood  
July 4, 2024  
ETi File ET124018

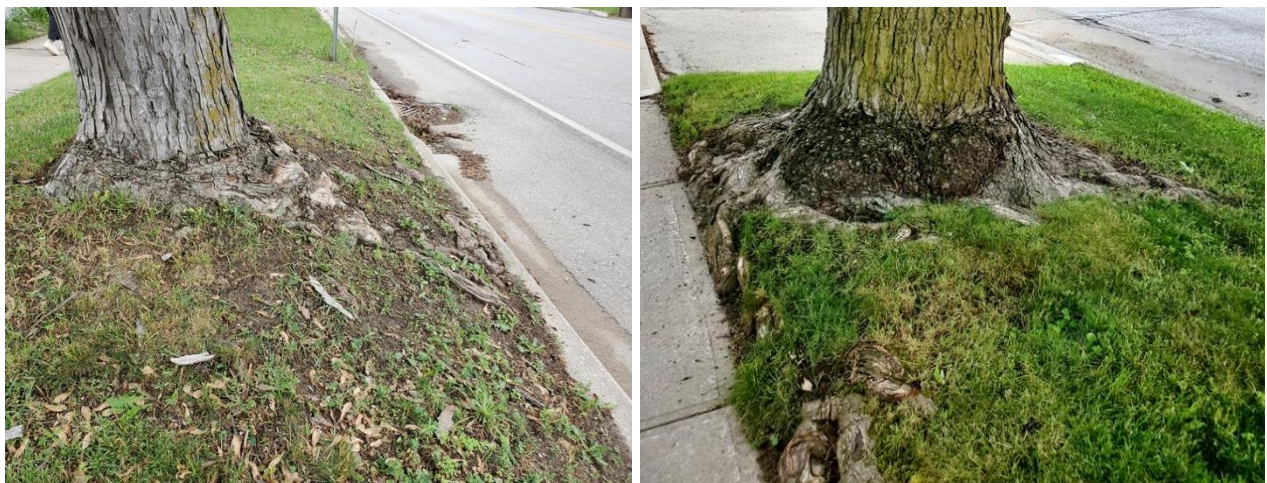
Among those trees in the “Fair-Poor” & “Poor” categories, there were some common concerns. The bases of several mature trees, most notably the Silver Maples, were mounded above existing grade and as a result, many had scalped or cut surface roots which may have opened a route for decay (**Figure 2**). It was also noted that several sidewalk panels had been replaced near these trees, likely due to sidewalk heaving. Several of the inventoried trees also had large pruning cuts which had not healed over, with decay often present (**Figure 3**). Further to this, all three Ash were suffering significant decline due to the Emerald Ash Borer and should be removed.

**Figure 2** Base of mature trees mounded above adjacent grade (often with damaged surface roots and potential decay).

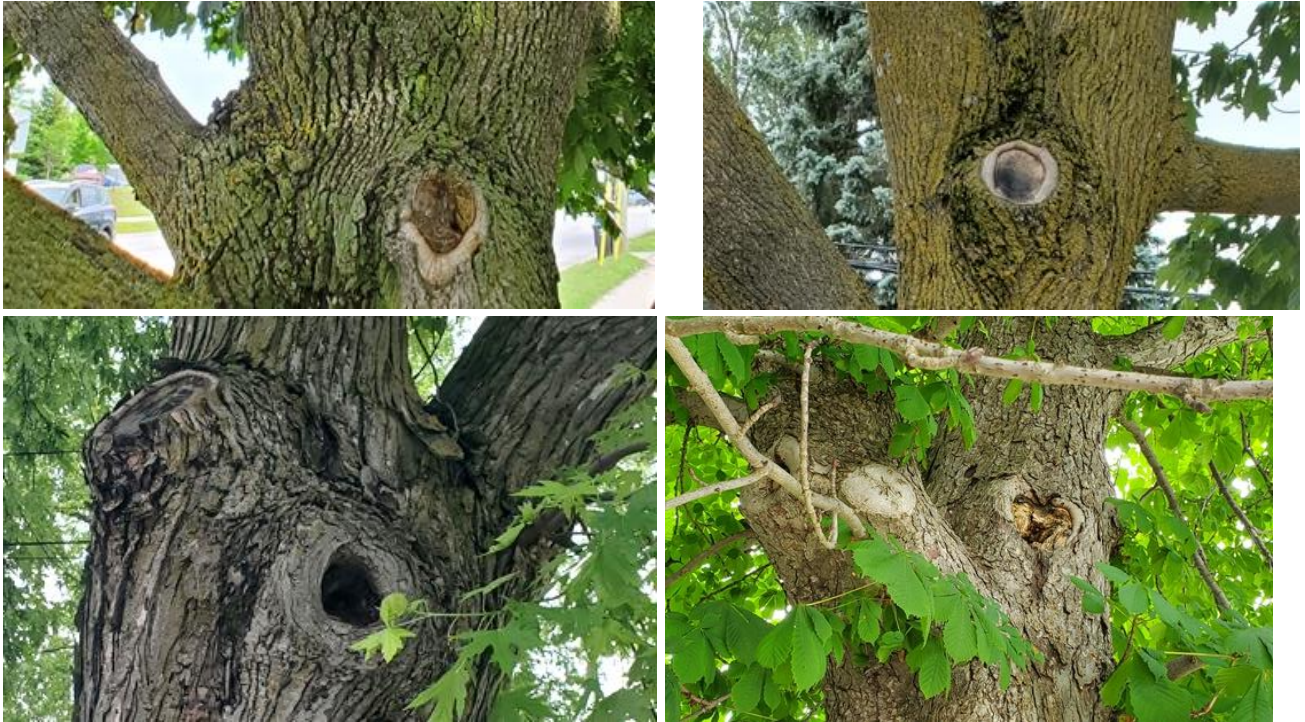
**Figure 3** Pruning cuts that have not healed over, with various degrees of decay.

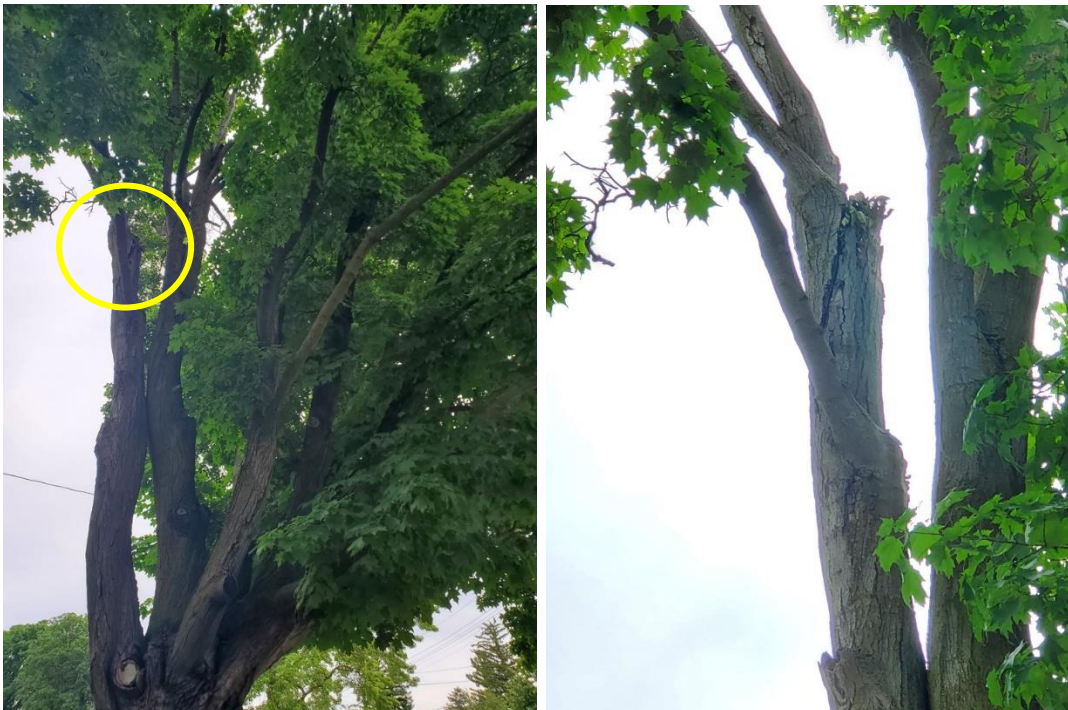
**Figure 4** Potential branch failure at 77 Sixth Street.

Among the privately owned trees, we recommend immediately addressing a potential branch failure in a Sugar Maple located at 77 Sixth Street (**Figure 4**) as the branch is adjacent to the house and fence.
